Fiscal Year 2012 Revegetation Assessment

November 2012

INL/EXT-12-27776

**Idaho National Laboratory
Idaho Falls, Idaho 83415**

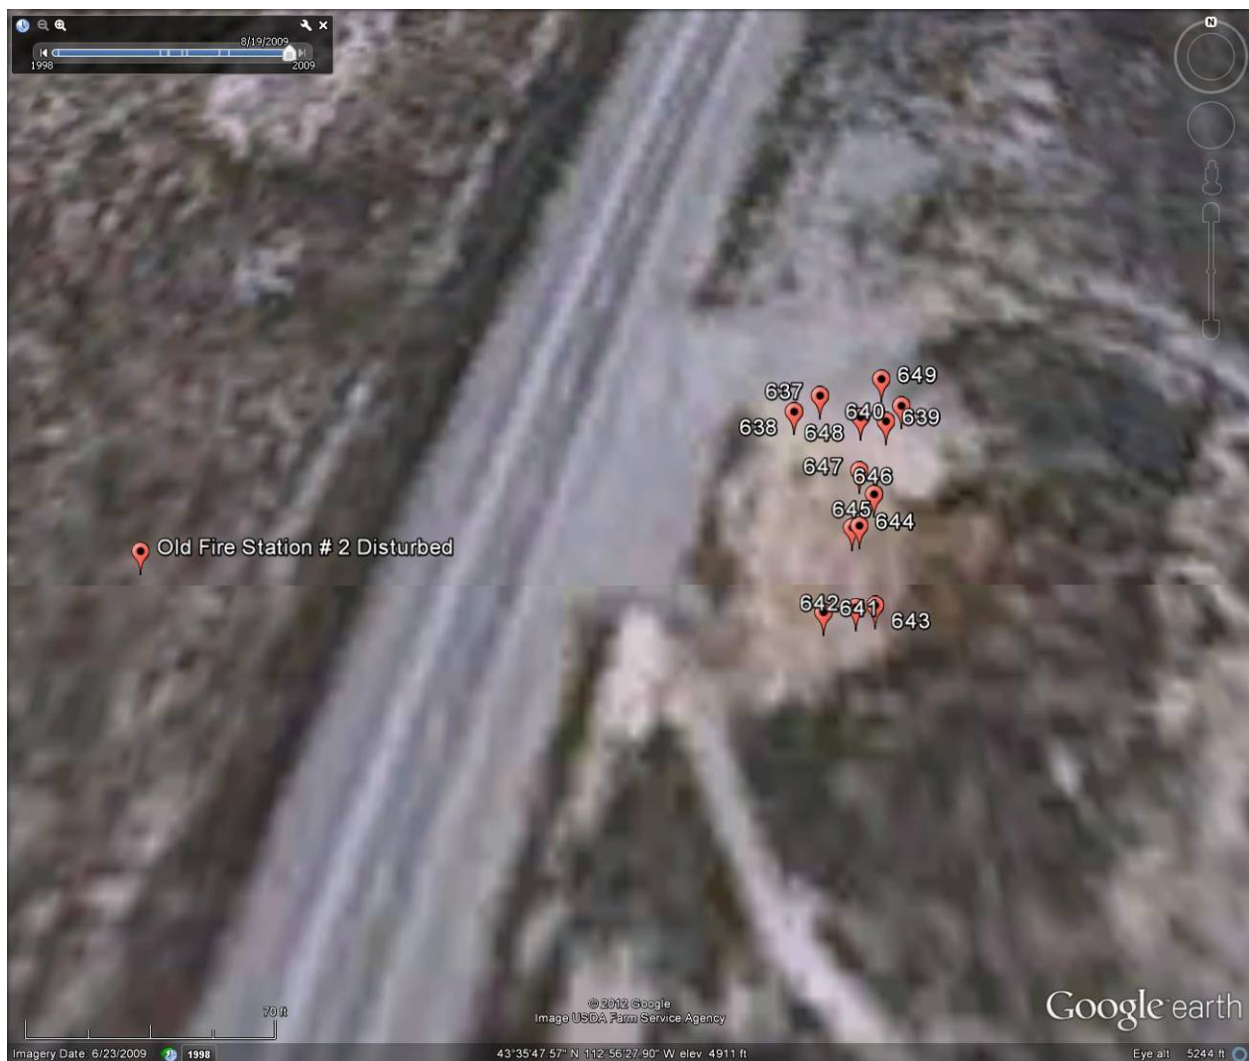
Figure 6. CFA Former Fire Station 2 Disturbed Area Transects.

Vegetation appears to be uniformly distributed throughout the disturbed area, but a small bare area is present near the center of the site. Wood chips in this area are fairly thick. The assessment of the disturbed area was limited to the area with wood chips since distinguishing the rest of the disturbed area from the background vegetation was difficult. The area assessed appears to be the area reseeded in 2005. Transects were located as shown in Figure 6. One transect was placed running east to west through the center of the disturbed site and another running north to south. Table C-3 lists GPS coordinates for plots at this location. Figure B-5 shows a typical background vegetation plot. A Background transect was placed south of the site as shown in Figure 7.

Mean perennial cover of the disturbed area at the CFA Former Fire Station 2 site is 80.0% (Table A-3) of background, and there was no statistically significant difference between mean cover values of the disturbed area and background ($p=0.543$). Figure B-6 shows vegetation typically encountered in the disturbed area.

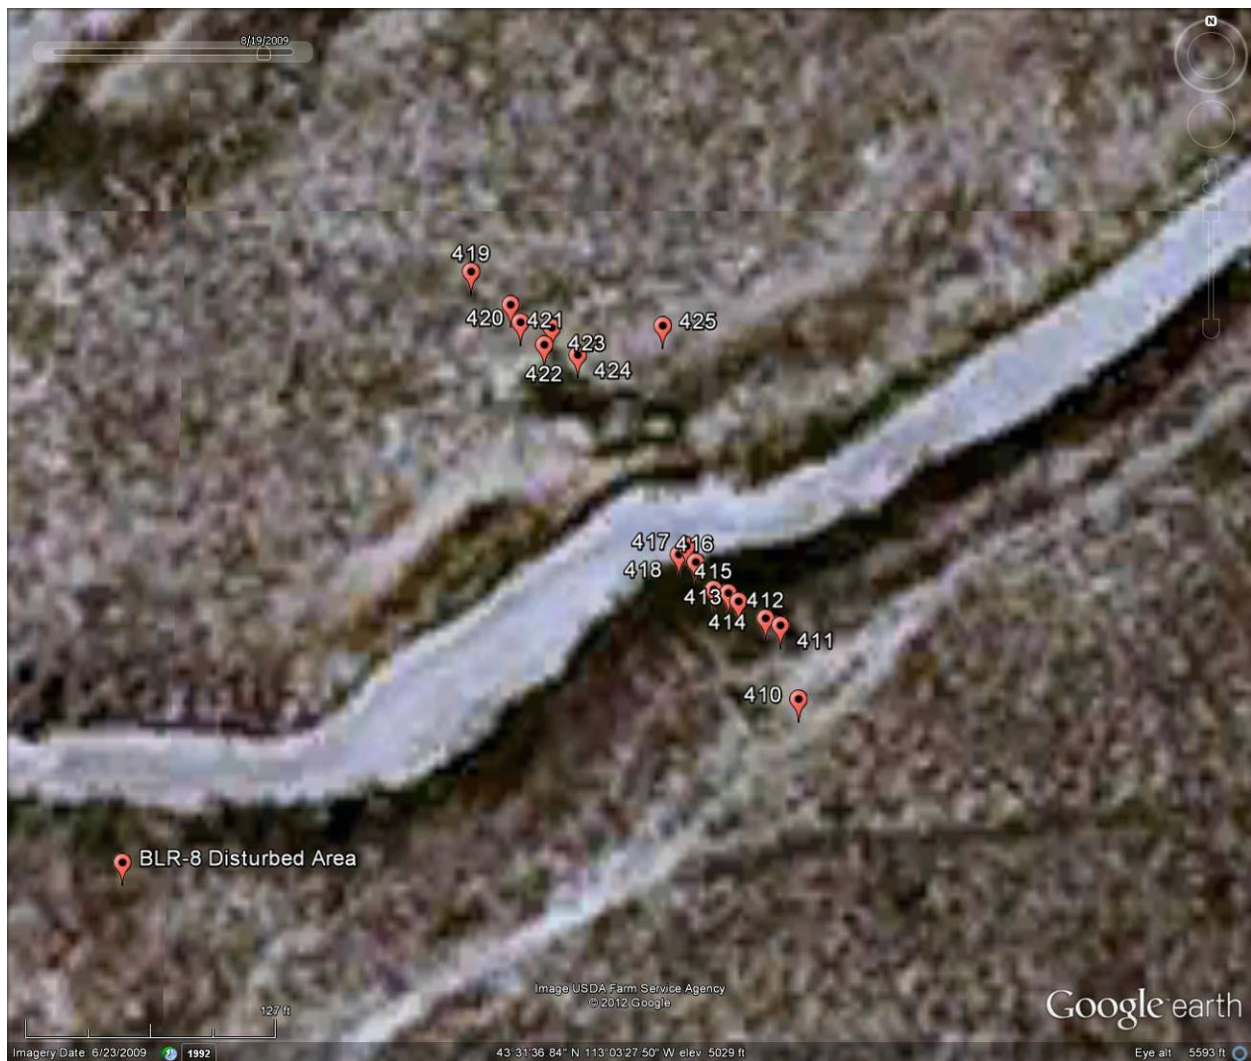
Figure 9. North and South Saddle Trenches Disturbed Area Transects.

Disturbed area transects were located as shown in Figure 9, and GPS locations are included in Table C-4. Disturbed area transects were run down the middle of the trenches parallel to the long axis. Figure 10 shows the location of the background transect for trenches associated with the GI project. Table C-6 contains GPS locations for the background vegetation.

Cheatgrass is prevalent in both trenches. In the north trench, needle and thread grass, bottlebrush squirreltail, and Indian ricegrass plants were observed. Other species identified were Wyoming big sagebrush, green rabbitbrush, orange globemallow (*Sphaeralcea munroana*), and western tansymustard (*Descurainia pinnata*), though mustard species were rare compared to previous years. Cover in disturbed area of the north trench has reached 40.5% of background (Table A-4) and there was no statistically significant difference between cover values for the disturbed area versus background ($p=0.366$).

Perennial grasses in the South trench included western wheatgrass, needle and thread grass, bottlebrush squirreltail, and Indian ricegrass. Orange globemallow and silvery lupine (*Lupinus argenteus*) were also observed. Cover in the disturbed area is 54.3% of background (Table A-5) and there was a statistically significant difference in total mean cover between background and the disturbed area ($p=0.020$).

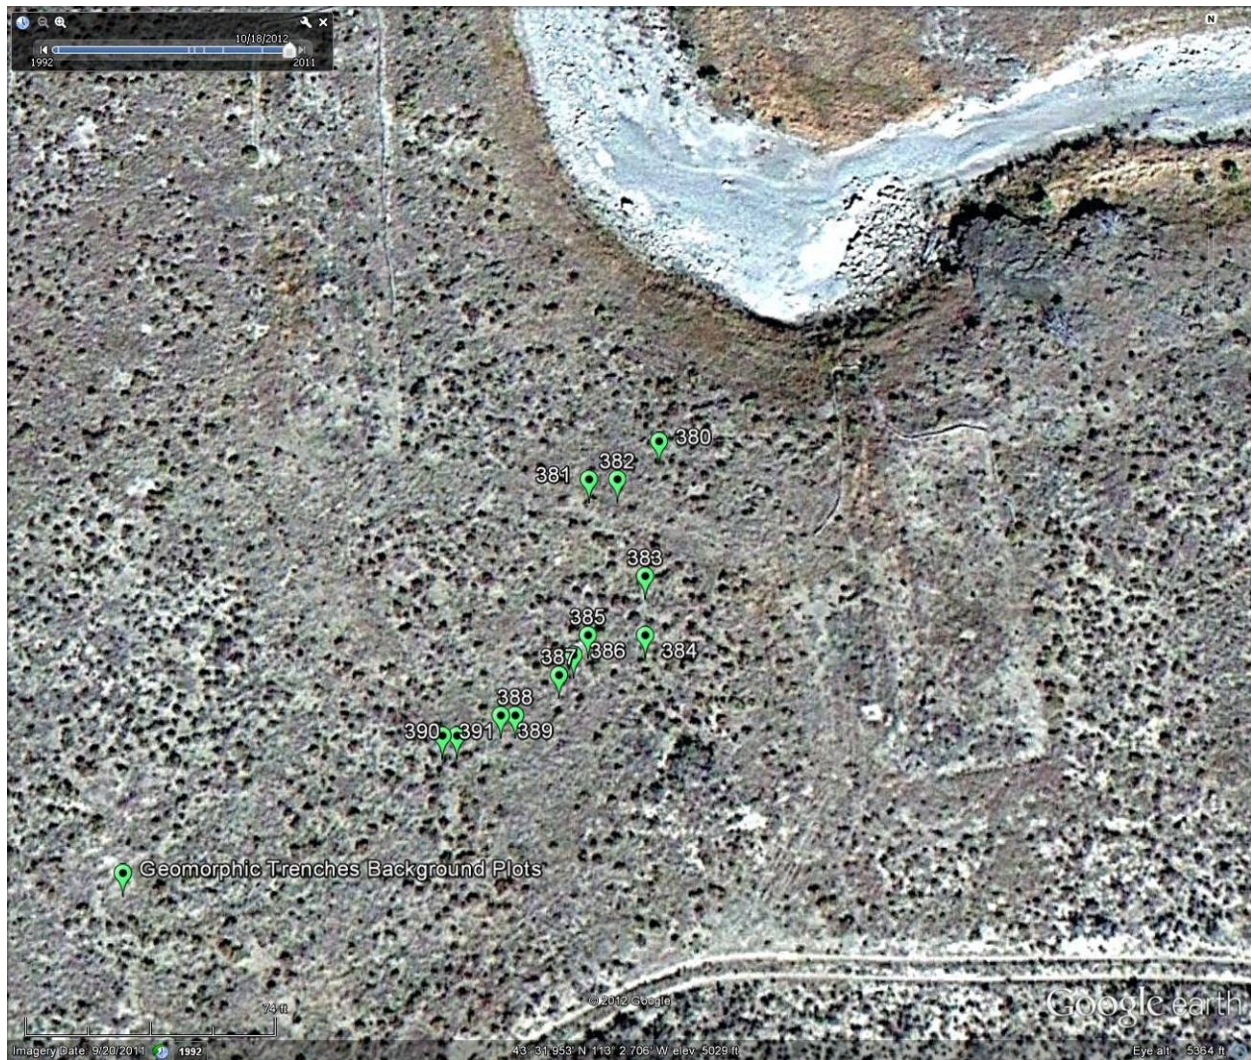
Figure 10. Geomorphic Investigations for Flood Bounds Background Area Transect.

The background transect for this location is the same as that used for the Saddle Trenches as shown in Figure 10. Disturbed area transects were placed as shown in Figure 11, and GPS locations are included in table C-5.

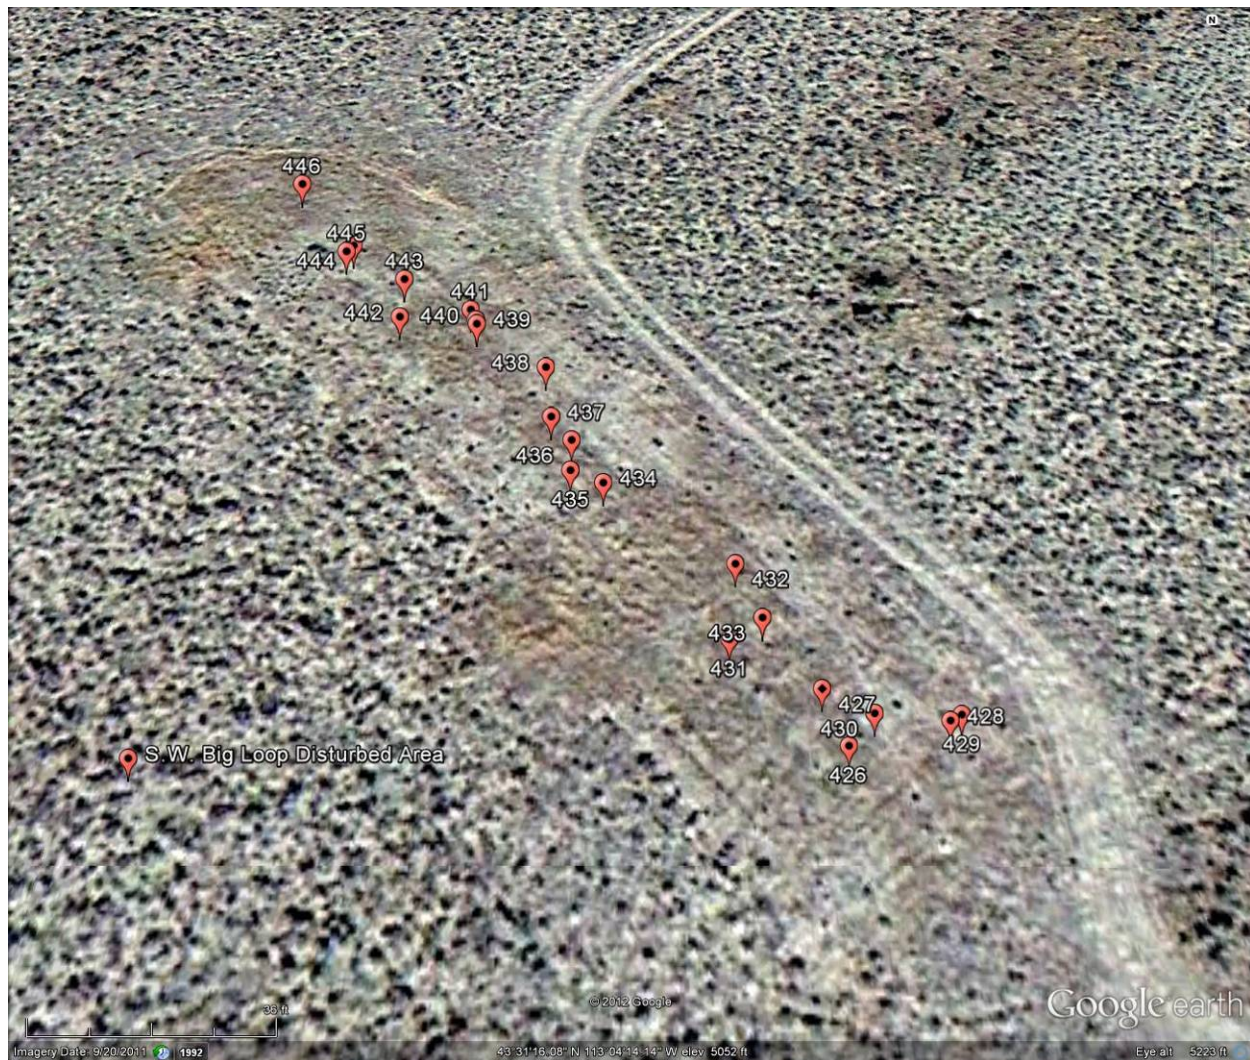
Figure 11. Southwest Big Loop Trench Disturbed Area Transect.

The southwest Big Loop Trench is dominated by cheatgrass. Forbs observed included: silvery lupine and shaggy fleabane. Perennial grasses included bottlebrush squirreltail, Sandberg bluegrass, and thickspiked wheatgrass. Wyoming big sagebrush plants were also found on this site.

Cover in the disturbed area is 13.1% of background (Table A-6) and there was a statistically significant difference for cover in the disturbed plots versus background ($p = <0.001$) which is likely due to the high amount of cheatgrass in the disturbed area (annual species in the disturbed area are 939.9% of background levels).

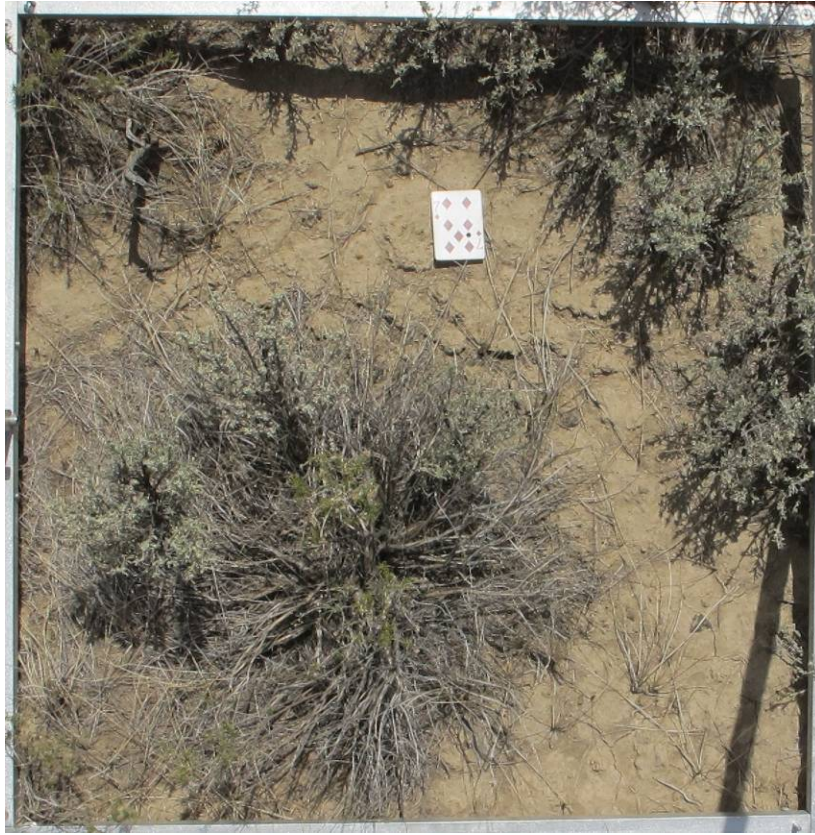
Vegetation appears to be uniformly distributed throughout the disturbed area, and large bare patches were not observed. Thickspike and western wheatgrass were the most common native grasses encountered during this assessment. Transects were located as shown in Figure 4. Table C-2 lists GPS coordinates for plots at this location. Figure B-3 shows a typical background vegetation plot.

Figure B-3. Background Vegetation Plot at CFA-4 Pond Remediation Site.

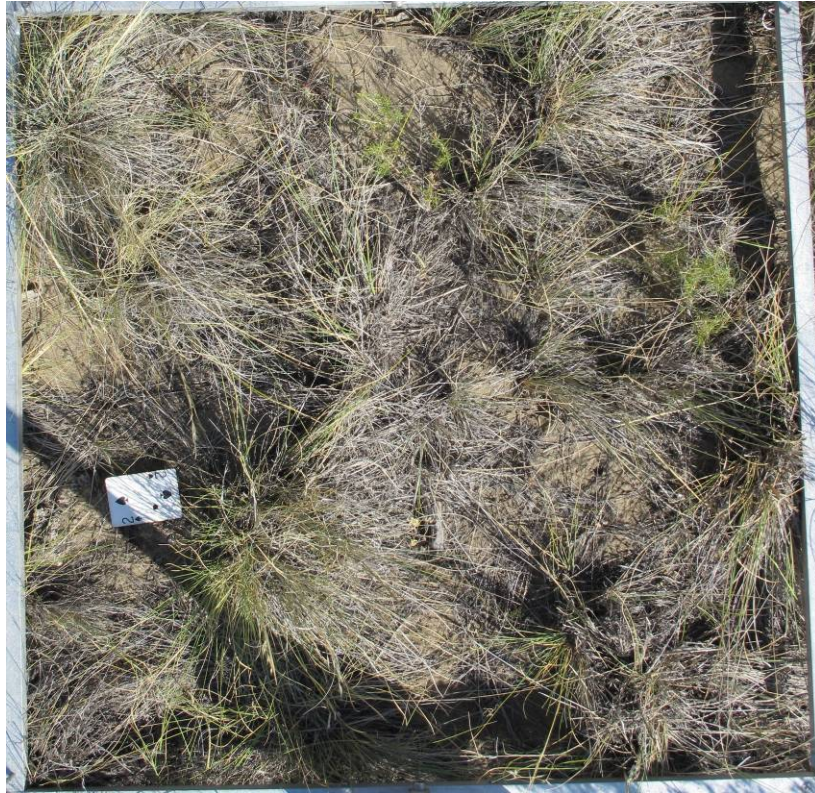
Figure B-7 is a plot representative of background vegetation for the trenches associated with the Geomorphic Investigations for Flood Bounds. Figures B-8 and B-9 represent plots typically found on the north and south Saddle trenches respectively.

Figure B-7. Background Vegetation Plot at the Geomorphic Investigations for Flood Bounds.

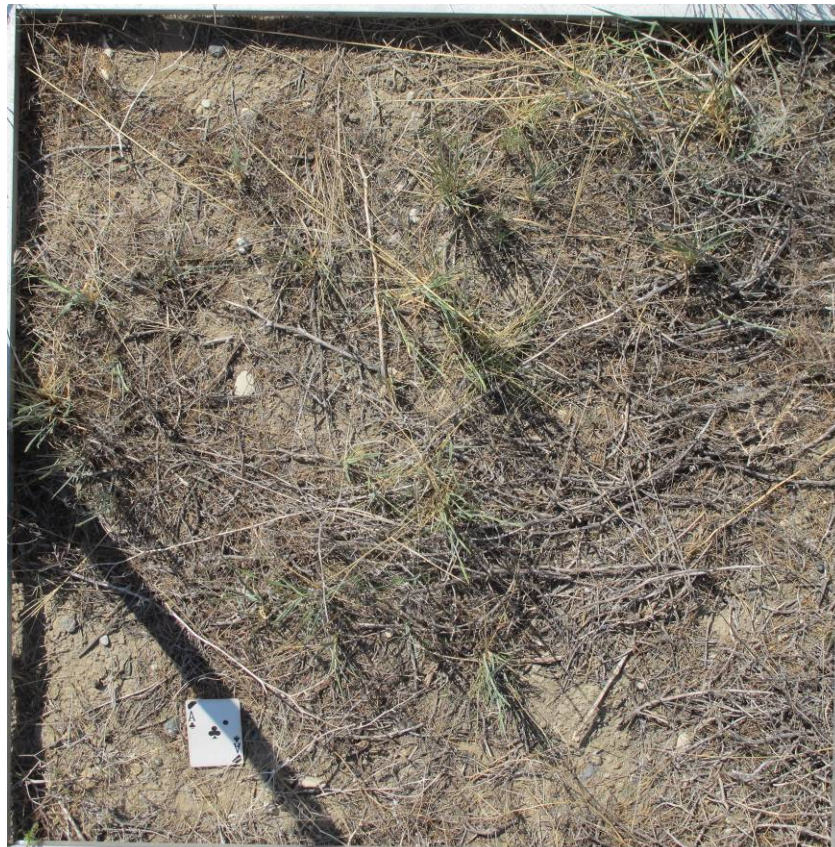
Figure B-8. Disturbed Vegetation Plot at the North Saddle Trench.

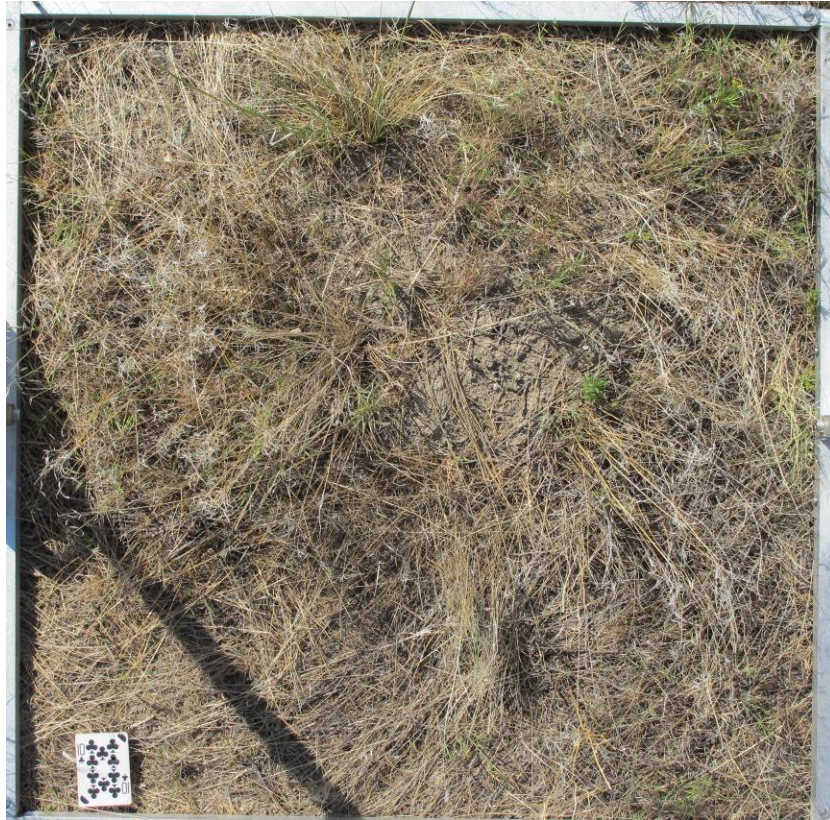
Figure B-9. Disturbed Vegetation Plot at the South Saddle Trench.

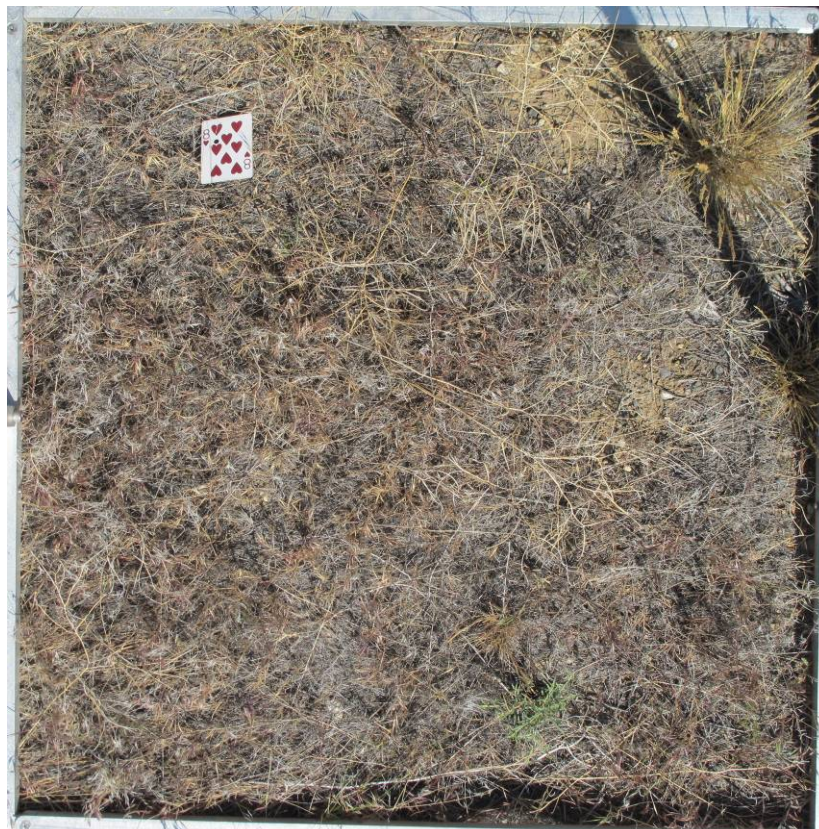
Figure B-10 is representative of plots found on the southwest Big Loop trench.

Figure B-10. Disturbed Vegetation Plot at the Southwest Big Loop Trench.

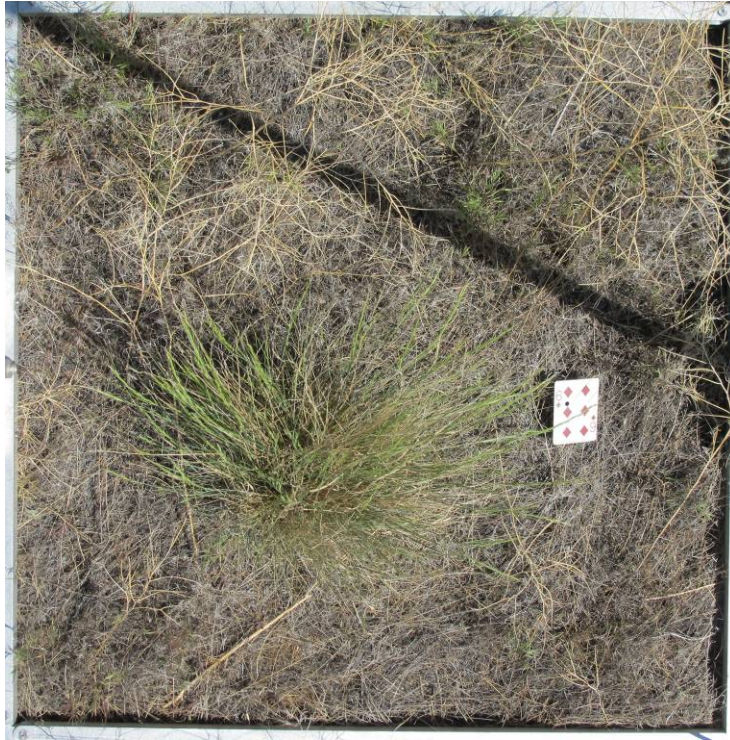
Native perennial vegetation in the disturbed area around well 209 is 49.8% of background (Table A-10), and there is a statistically significant difference between mean cover for the background and disturbed vegetation ($p=0.001$). The site has not achieved final stabilization.

Figure B-17. Disturbed Vegetation Plot for Well 209.

Wells 202A, 203, 204, and 209 still exhibit a high concentration of annual species such as tansymustard and cheatgrass. These wells are all located adjacent to the berm of the new INTEC Percolation Ponds. It does not appear that weed control has been conducted on the graveled berm. Cheatgrass on the berm provides a constant seed source to the disturbed areas of the wells adjacent to it. Even if intensive restoration of the disturbed areas around those wells were to take place, it is likely that cheatgrass would continue to invade.
